JARBIDGE RIVER STREAM CHANNEL INTEGRITY INVENTORY

Elko County, Nevada

Humboldt-Toiyabe National Forest
2035 Last Chance Road
Elko Nevada 89801
(Contract 53-0261-01-08, Task Order SWINAO-4)

February 2002

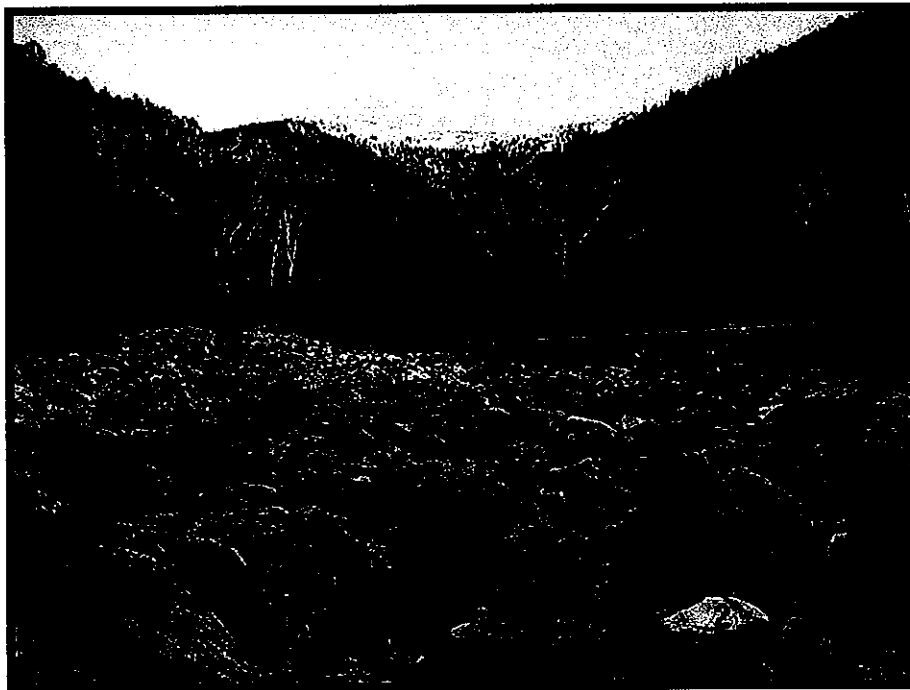
Photo 1-16, looking upstream into Snowslide Gulch. North distributary channel of Snowslide Gulch. Lichen covered and stained rocks in substrate in lower center of photo suggest pre-1995 bed-elevation. Map Plate 1a Location: Snowslide Gulch, near W-12

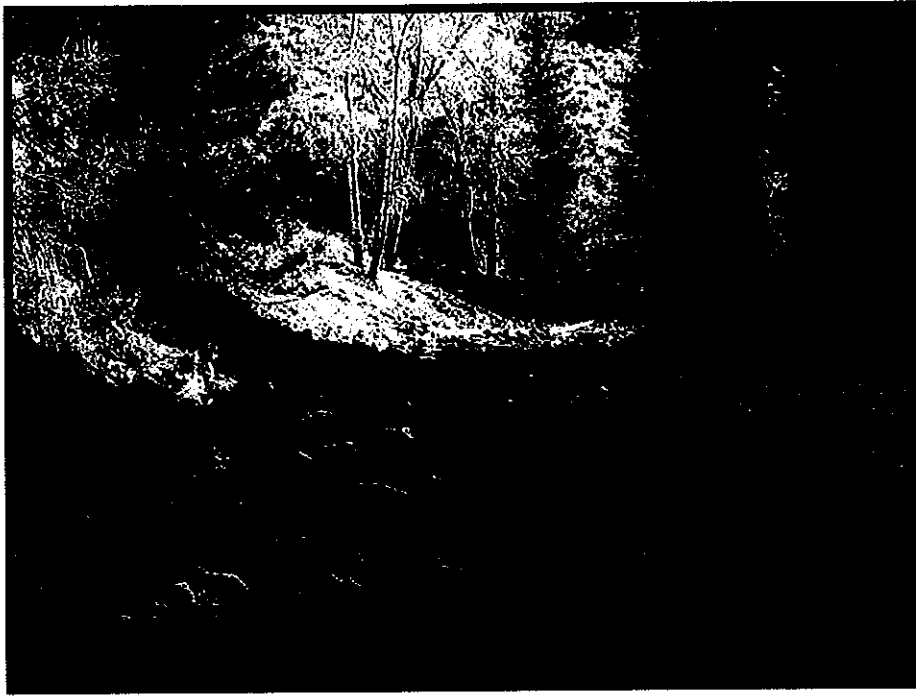
Photo 2-11, looking upstream. Channel incised in debris fan. Road on right edge of water.
Map Plate 1a Location: W-37

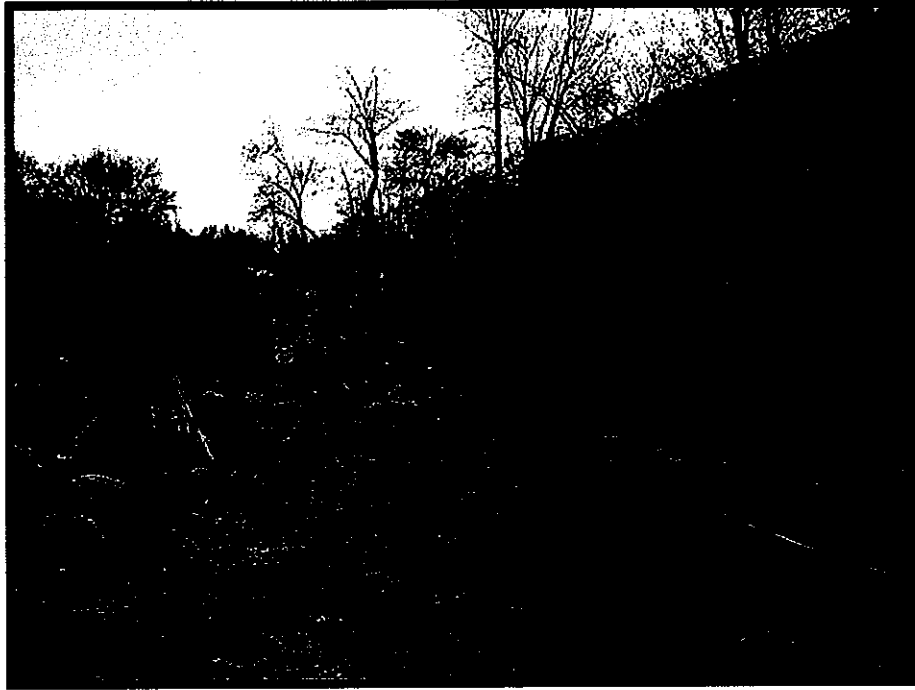
Photo B-29, looking downstream. Location Br-9. Note failing fill at left abutment.

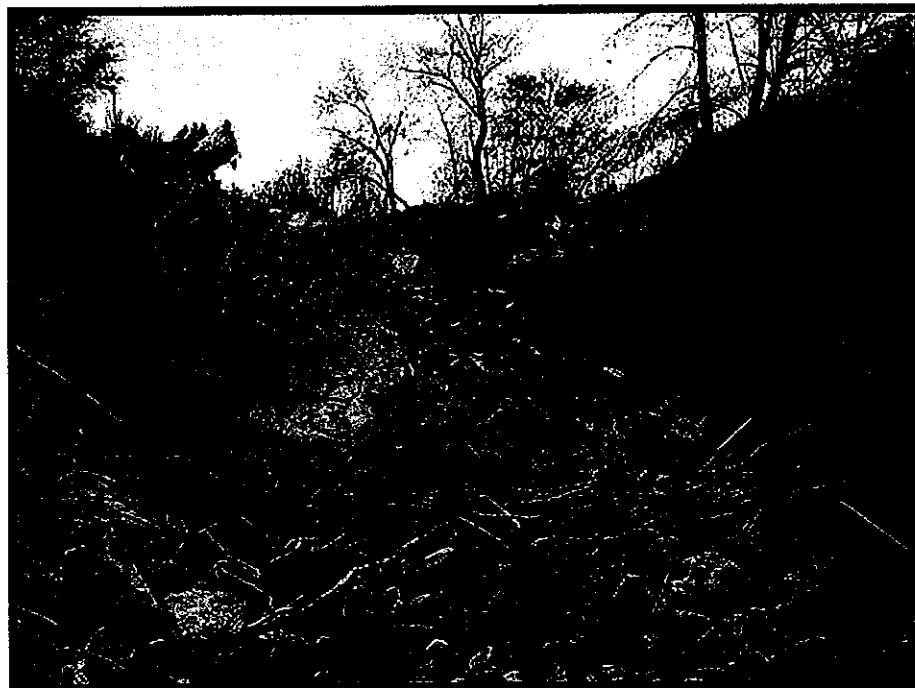
Photo B-30. Location Br-9. Failing fill at left abutment.

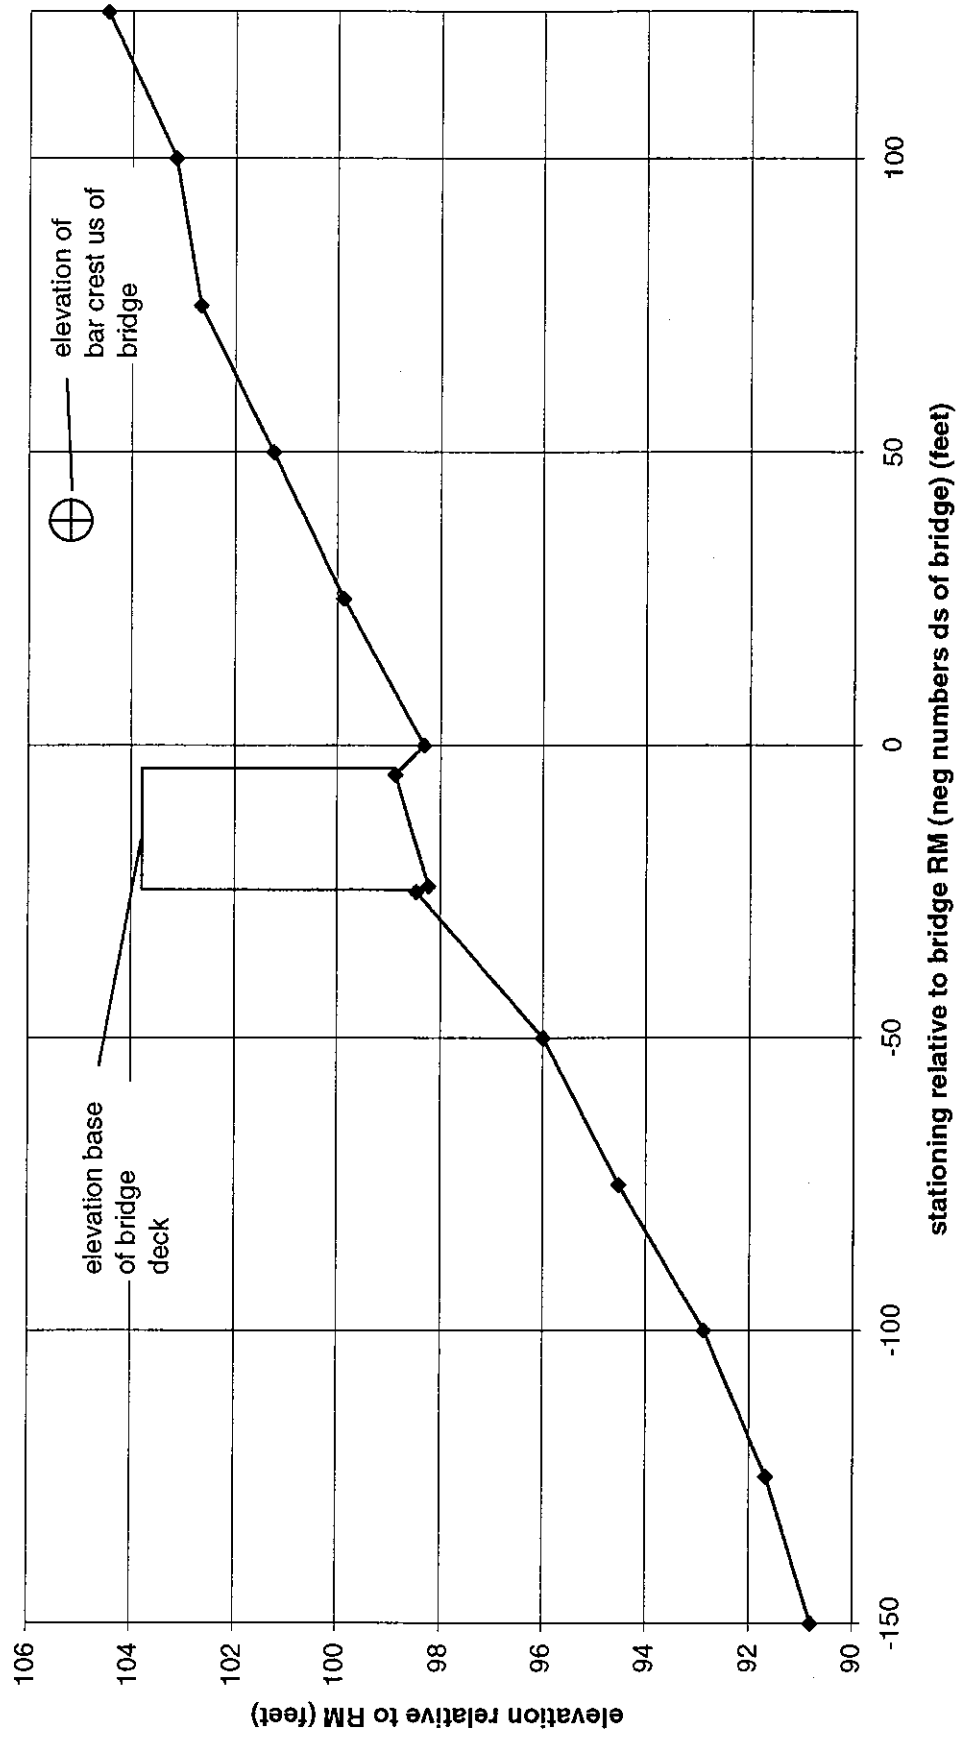
<u>Bridge Number</u>	Br 6658T												
<u>Bridge Opening</u>	18 feet wide, 3.5 feet high No intermediate piers												
<u>Upstream Conditions</u>													
<u>Channel</u>	Disturbed reach Channel captured by road during high flood event (1995) Channel avulsion occurred behind large wood debris jam - remnants still in channel, approximately 300 feet upstream of bridge Immediately upstream of bridge, active channel in road prism Coarse substrate - small boulder through cobble												
<u>Floodplain</u>	Road in accessible floodplain, lead to channel capture Channel does have access to valley width in this reach												
<u>Debris</u>	Woody debris upstream of bridge lead to abandonment of current bridge												
<u>Bridge Section</u>	Bridge does not convey flow Channel located on left approach to bridge Bed profile not completed due to bridge condition Aggraded section through current bridge opening												
<u>Downstream Conditions</u>	93 feet of road prism obliterated downstream of bridge section Channel still stabilizing from 1995 flood event Coarse substrate - small boulder through cobble												
<u>Summary</u>	Bridge section abandoned during 1995 channel avulsion Bridge section may be fully or partially reactivated due to unstable - channel conditions in reach Bridge in functioning condition is channel constriction Limited flow area may have partly initiated bridge failure due to - debris blockage in approach section
